Using GPR on a problematic agricultural field for groundwater protection in a karst environment

Marjana Zajc & Janko Urbanc, Geological Survey of Slovenia

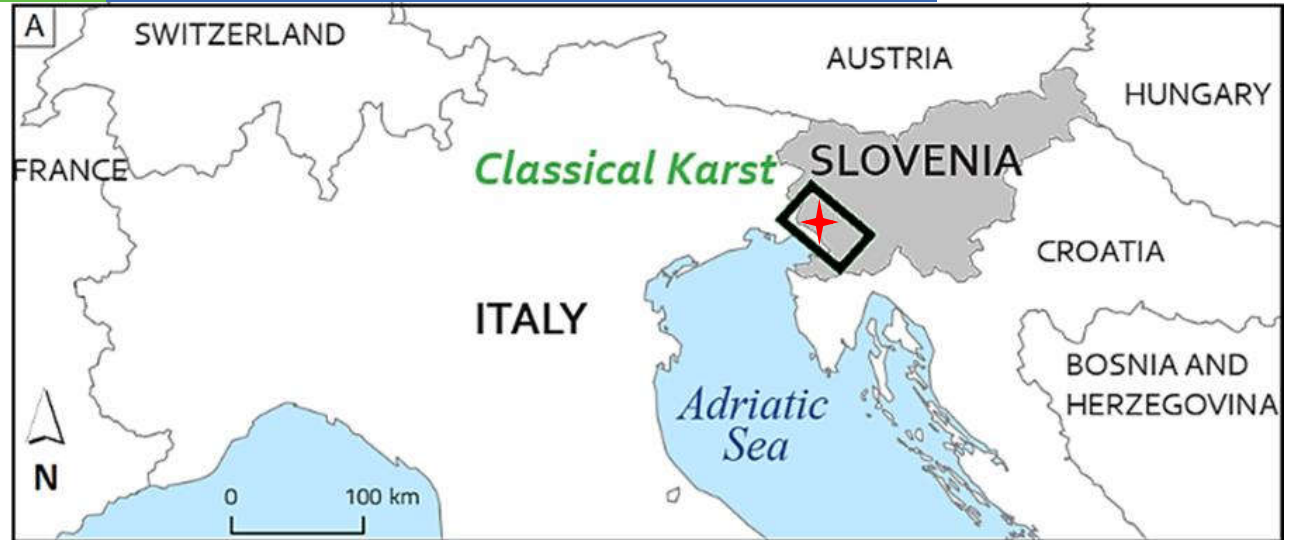
- Situated in a karst area
- No problems on neighbouring fields (yellow)
- Patchy and poor growth despite additional irrigation and fertilization (red)

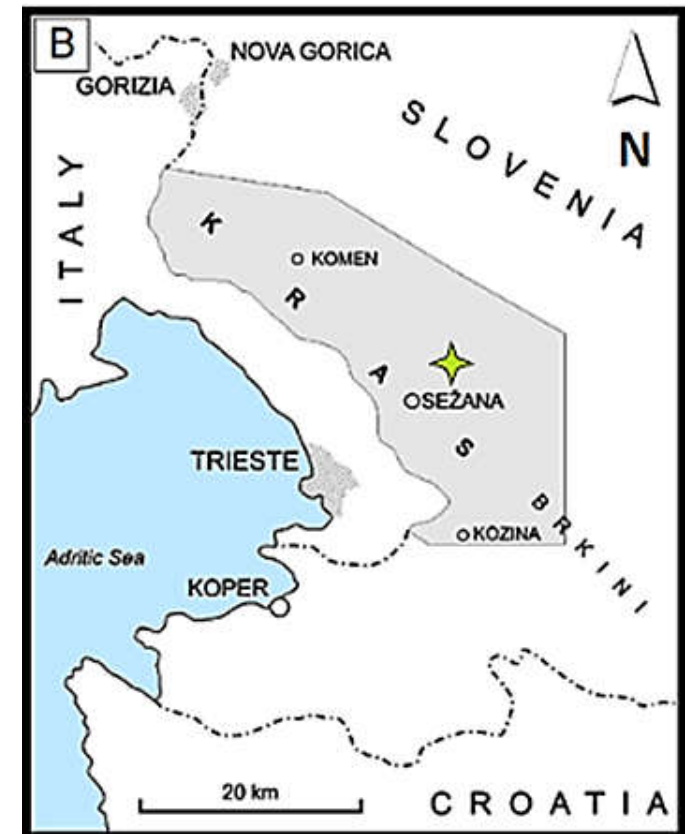
Karst aquifer

- **Classical karst aquifer:**

- important transboundary aquifer
- vital source of drinking water for Slovenia and Italy
- specific hydrogeological conditions
 - ➔ complex and heterogenous area
 - ➔ high groundwater vulnerability
- remains inadequately protected (Turpaud et al., 2018)

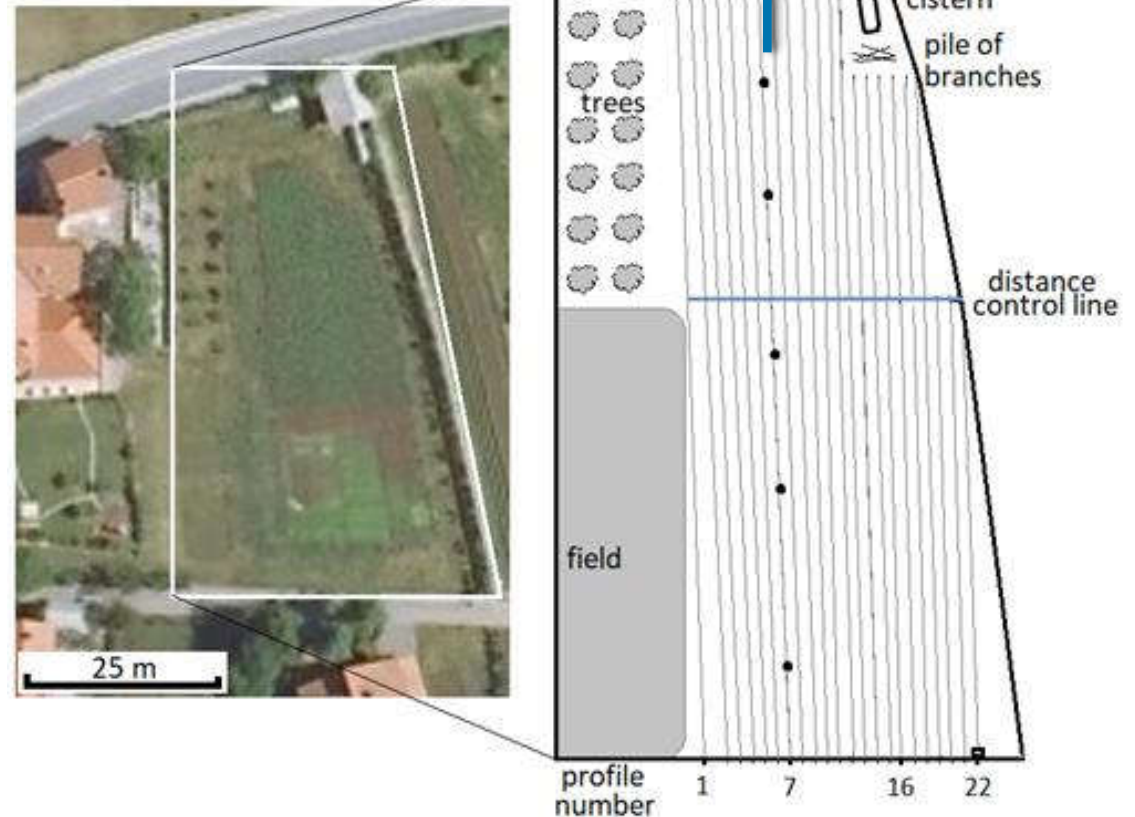
- 22 GPR profiles across the entire field
- Malå ProEx recording unit,
250MHz, 500 MHz antennas
- Parallel profiles 1 m apart
- Wheel acquisition mode 0.02 m
- Top soil thickness calibration:
digging of 5 holes along P7
- Processing in ReflexW Sandmeier
 - Time-zero adjustment
 - DC shift
 - Background removal
 - Gain
 - Bandpass filtering
 - Time-to-depth conversion by hyperbola fitting

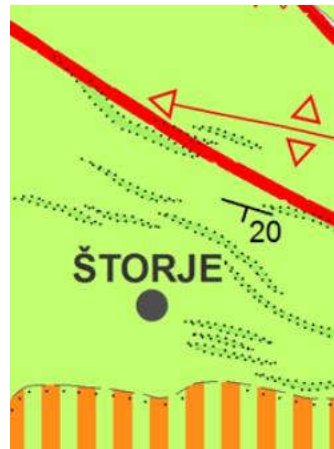
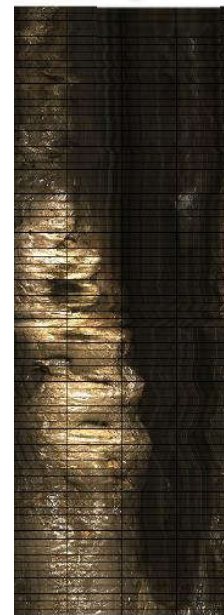
Comparison of GPR and borehole televiewer results

limestone bedding

cavities

fractures

- GPR results confirmed with borehole logs
