## Field study tour #2 – Potoška planina landslide

The Potoška planina landslide has the ongoing status of an International Programme on Landslides (IPL) project “Study of the slow moving landslide at Potoška planina (Karavanke Mountains, NW Slovenia)” (IPL -188).

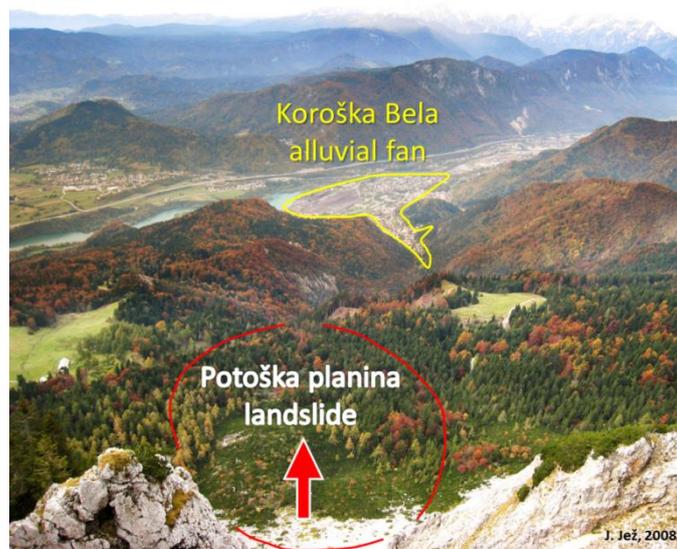
*Fig.2 A view from the top of the Potoška planina landslide looking directly down the slide to the underlying village of Koroška Bela*

The broader area of the Potoška planina landslide is known to have experienced severe debris-flow events in the recent geological past. The most recent of these events occurred in the 18th century and caused the partial or total destruction of more than 40 buildings and cultivated areas in a village down-slope (Koroška Bela) located in the area of the alluvial fan. Presently, some 2,200 inhabitants live in the area of the alluvial fan of past debris flows.

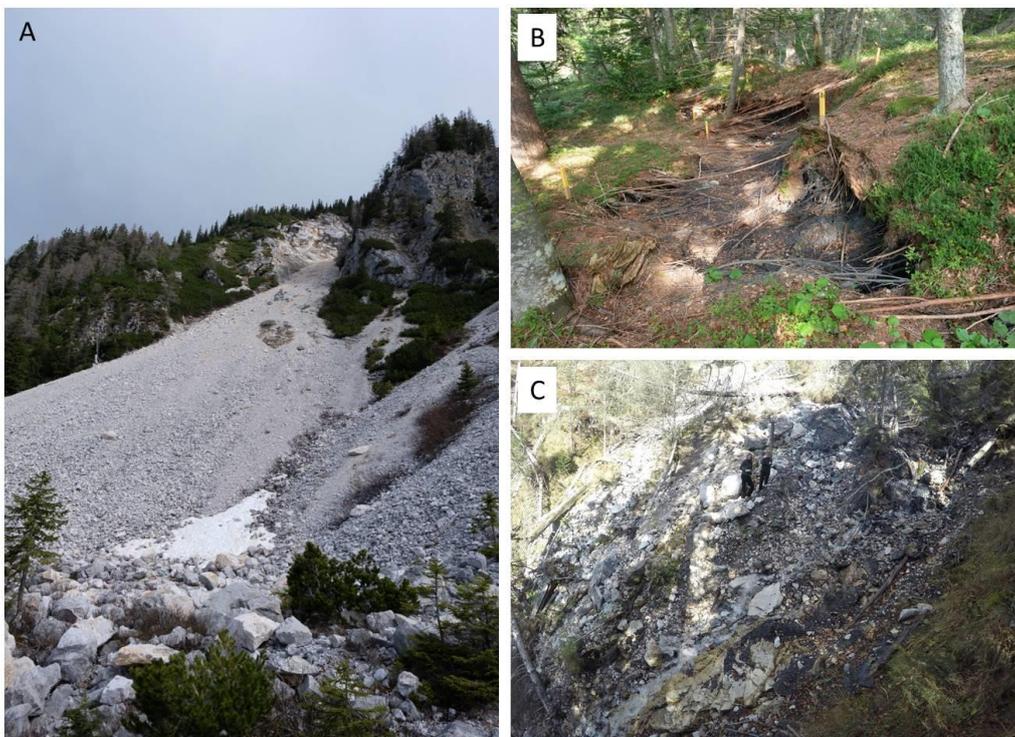
During the field trip we will observe rockslides and runoff of talus material in the upper part (Fig. 3A), to deep-seated slow-motion slide in the middle part (Fig. 3B) and active slope mass movements at the toe of the landslide (Fig. 3C), which is considered to be the most active part of the landslide. The sliding mass in this part is composed of tectonically deformed and weathered clastic rocks covered with a large amount of talus material, which is unstable and prone to landslides.

*Fig. 3 Potoška planina landslide is subjected to different slope mass movements*

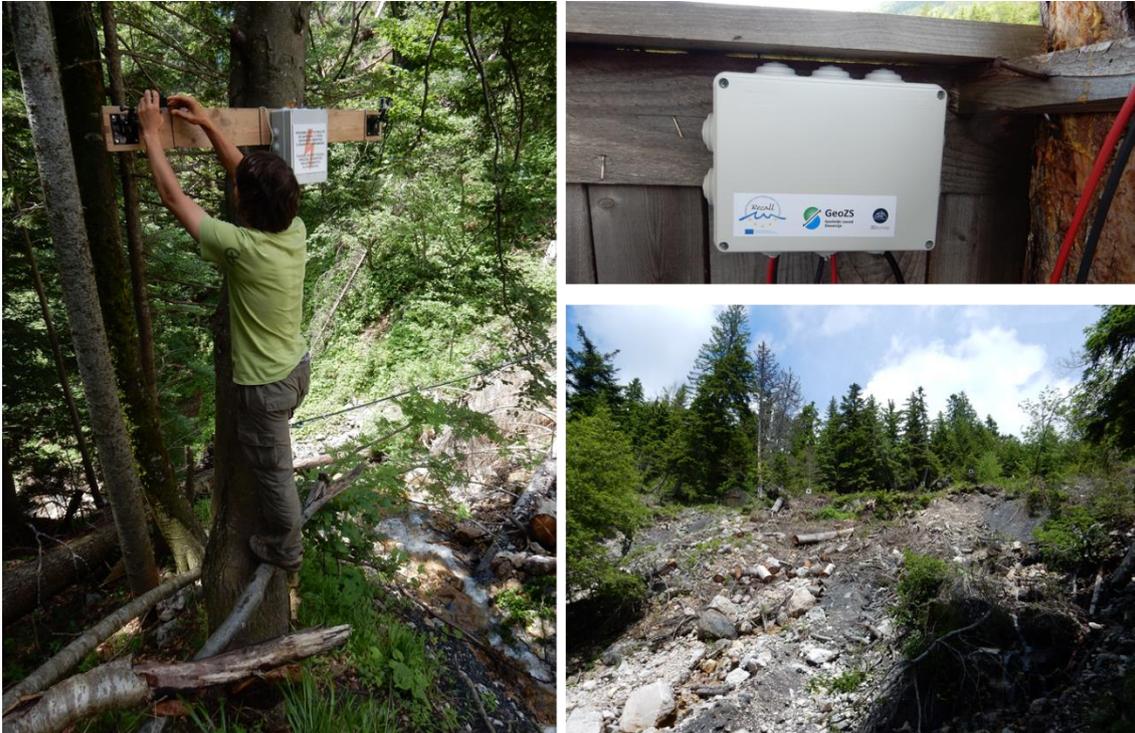
Along the way we will also see the new established monitoring system which serves for real-time monitoring of the surface patterns at the toe of the landslides (Fig. 4). Monitoring system provides images that are transmitted in real-time through network for transmission and enable immediate notification of landslide activity and landslide behaviour.

*Fig. 4:Real-time monitoring*
